Site Name: Progress Energy Asheville Date: 29 MAY 2009  
 Unit Name: 1964 POND Operator's Name: PROGRESS ENERGY  
 Unit I.D.: \_\_\_\_\_ Hazard Potential Classification: High Significant Low  
 Inspector's Name: FREDERIC SHMURAK / JUSTIN STORY

Site Name: Progress Energy Asheville Date: 29 May 2009  
 Unit Name: 1982 POND Operator's Name: PROGRESS ENERGY  
 Unit I.D.: \_\_\_\_\_ Hazard Potential Classification: High Significant Low  
 Inspector's Name: Frederic Shmurak / JUSTIN STORV

PHOTOGRAPH LOCATION PLAN  
OKLAHOMA LAKE DAM - PROGRESS ENERGY  
ASHEVILLE STEAM ELECTRIC PLANT  
OKLAHOMA AND NORTH CAROLINA

**PHOTOGRAPH LOCATION PLAN  
ASH PONDS - PROGRESS ENERGY  
ASHEVILLE STEAM ELECTRIC PLANT  
SKYLAND, NORTH CAROLINA**

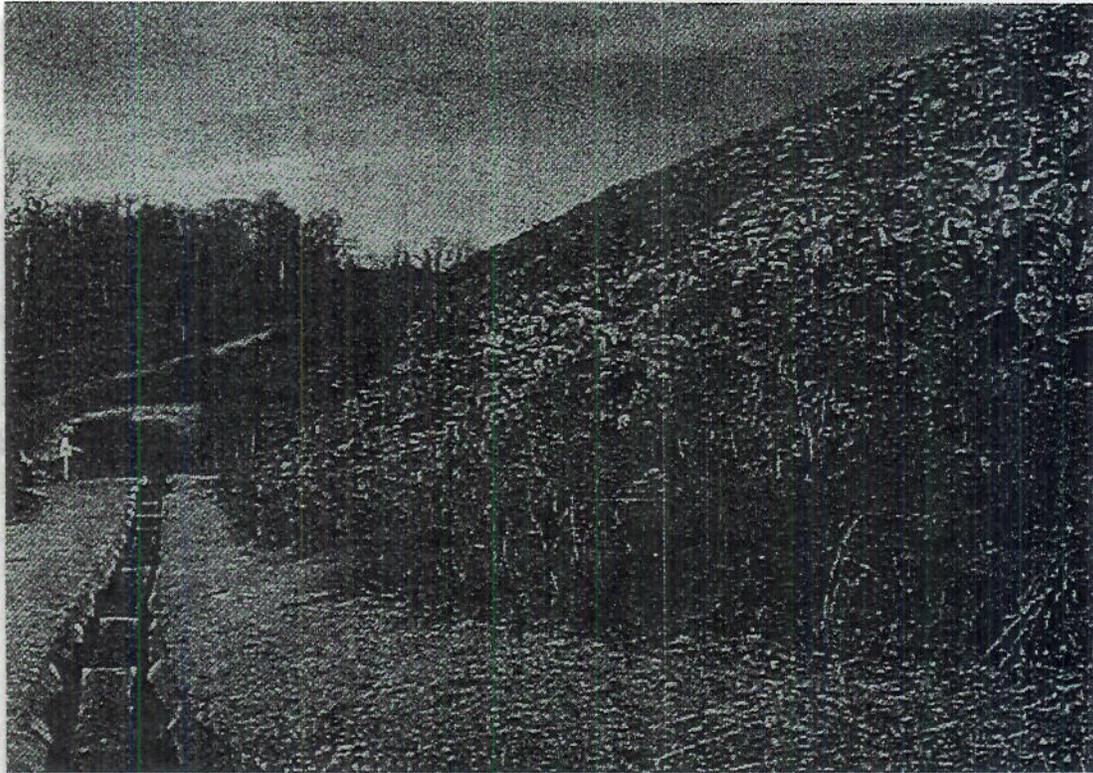
Photograph 13: 1964 Ash Pond – downstream slope looking northwest along toe of slope, note bushes growing in riprap.

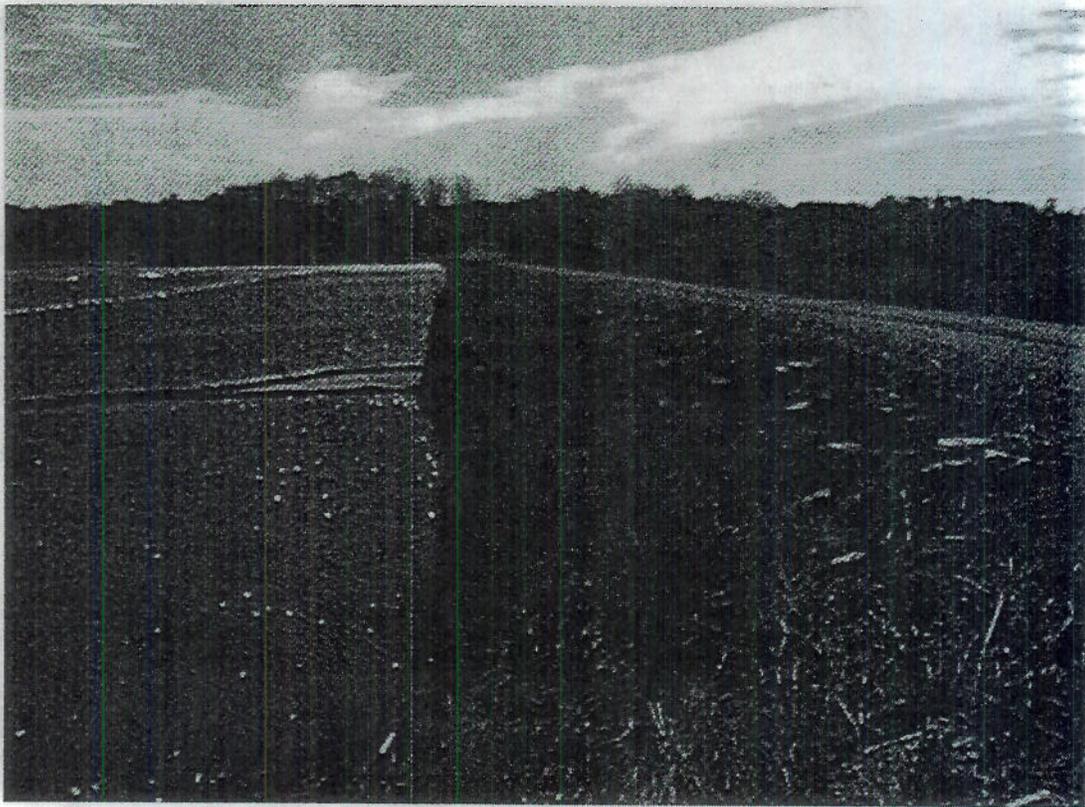
Photograph 15: 1982 Ash Pond, interior slope looking east, note vegetation in riprap.

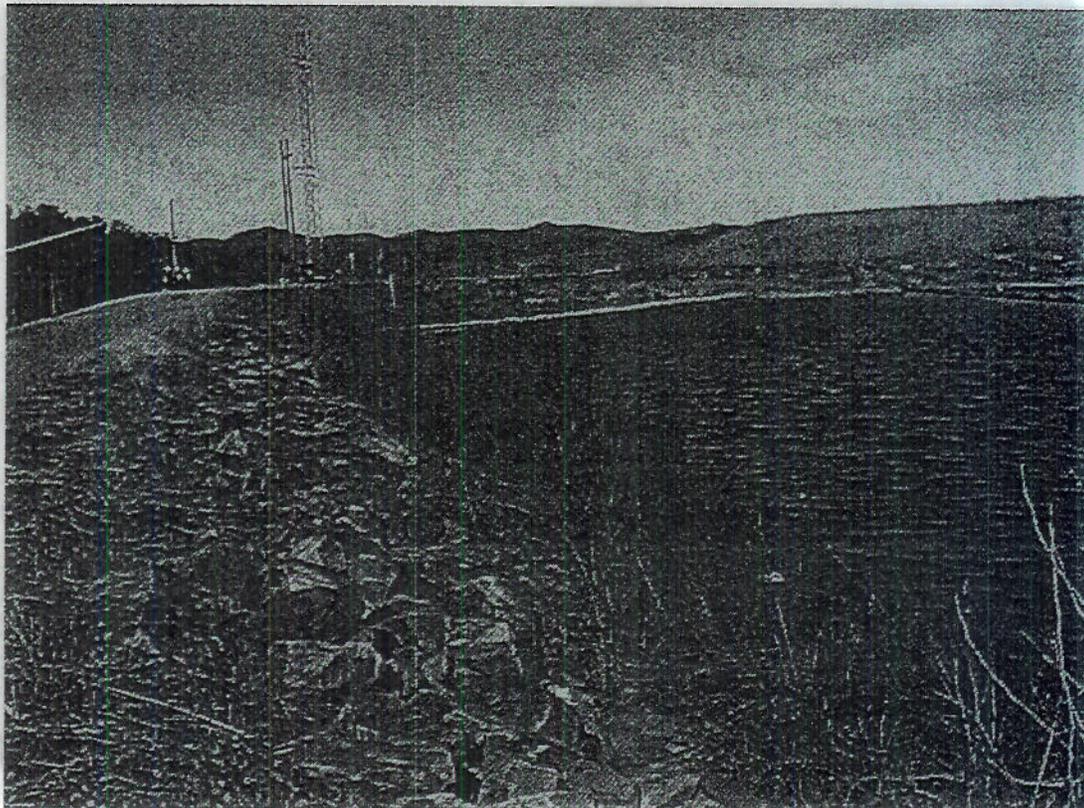
Photograph 16: 1982 Ash Pond - interior slope looking west, note vegetation in rip rap.

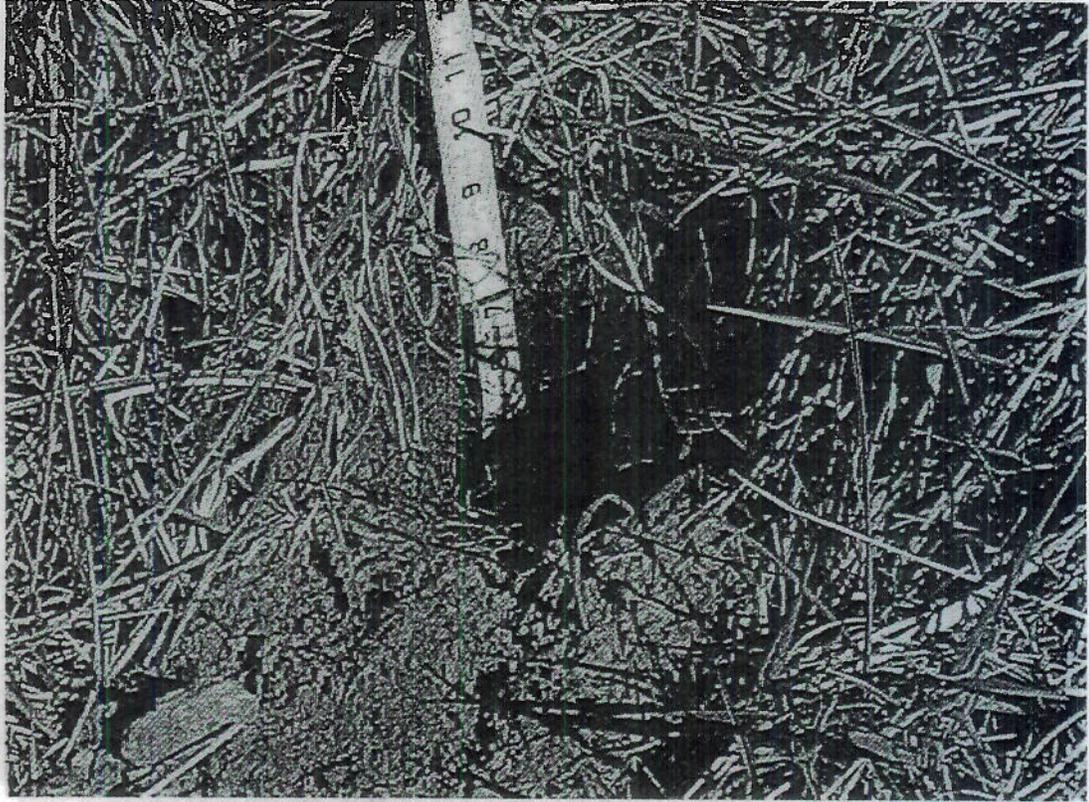
Photograph 19: 1982 Ash Pond – rodent holes in downstream slope.

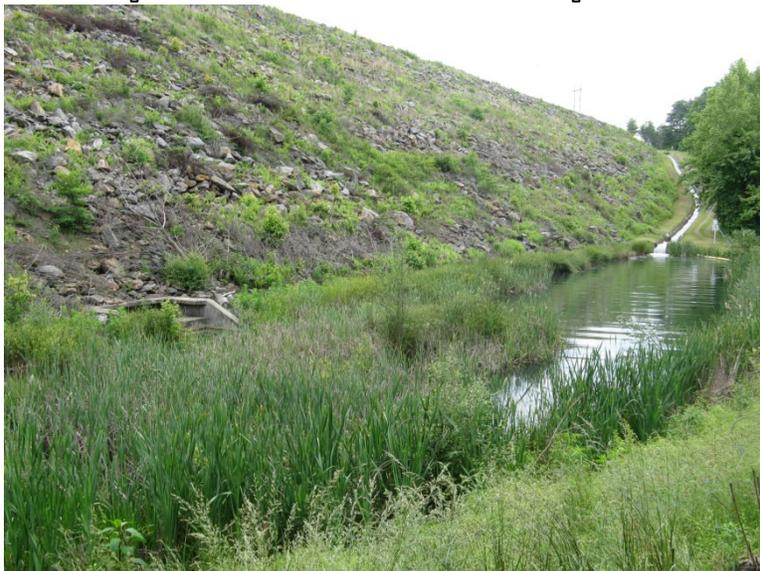
Photo 6: 1964 Dam - Concrete Flume Deterioration, Right Grain, Photo: 090, 5/29/09  
(note: right and left are based on the observer facing downstream)

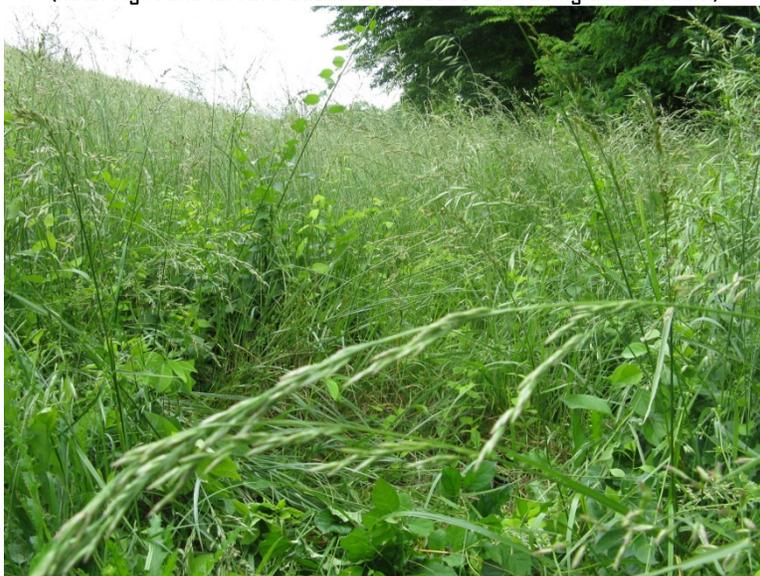
Photo 18: 1982 Dam – Minor Rill Erosion, Downstream Embankment, Photo: 033, 5/29/09
